## Application note

# Demagnetization of assembled bearings

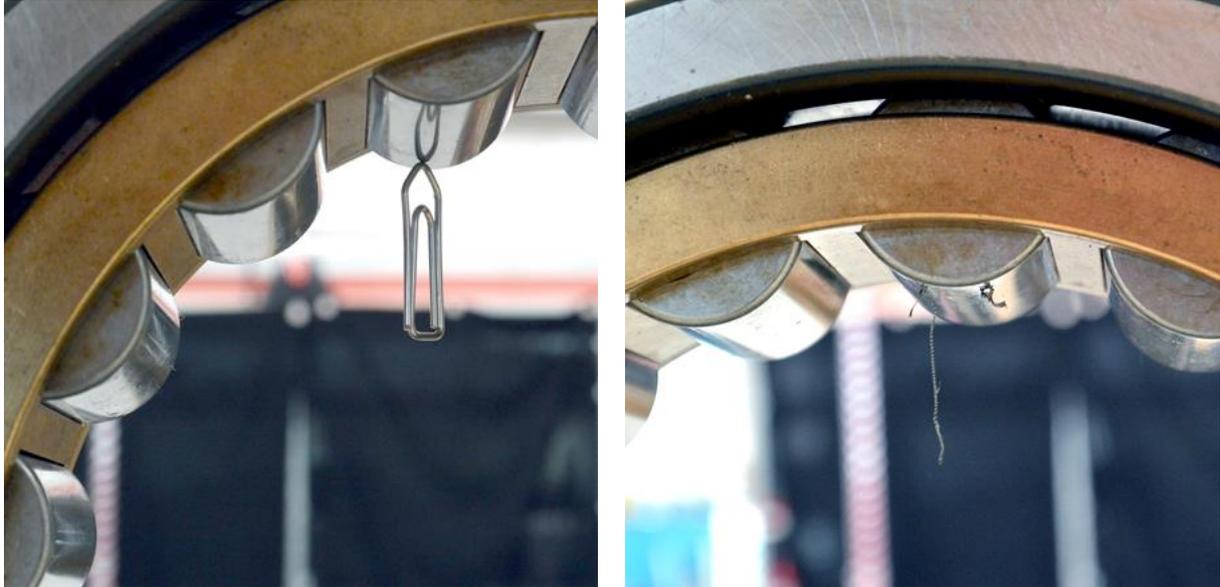
*Image: Magnetic cylindrical roller bearing (Maurer Magnetic AG)*

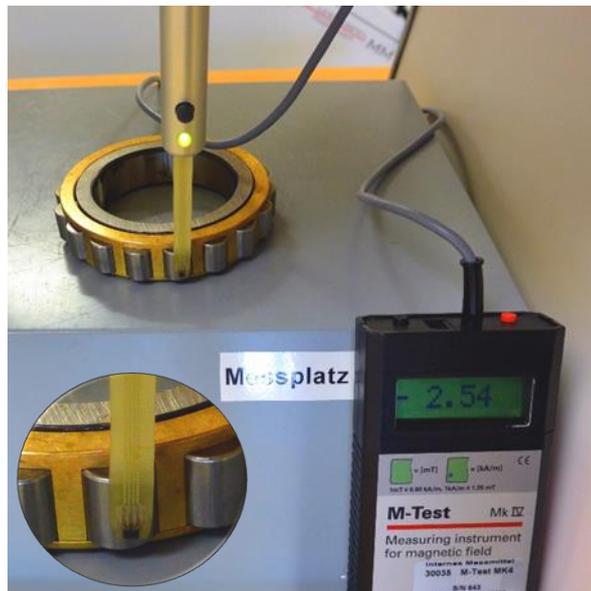
*Image: Measuring of rolling bodies on a roller bearing with inner ring. Result 2.54 mT (= 25.4 Gauss)*

While the rolling bodies of bearings without outer/inner ring can easily be measured, the running surface is not accessible with the probe.

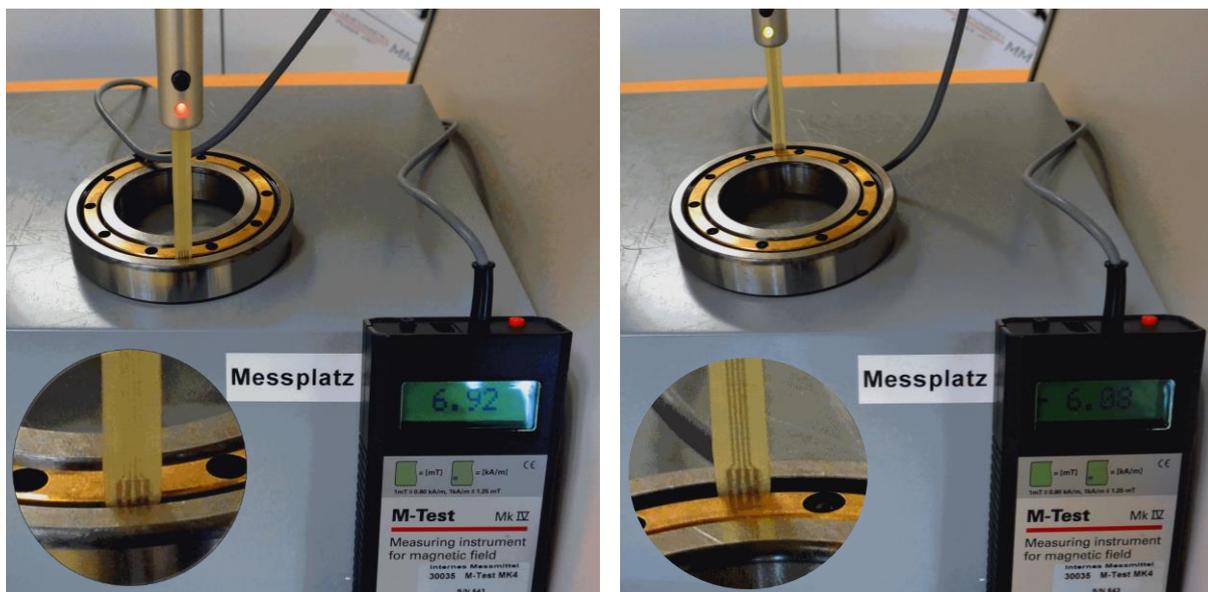
*Image: Measurement of rolling bodies and running surfaces on ball bearing. Result 6.92 / 6.08 mT (= 69.2 / 60.8 Gauss)*

Measuring of difficult to reach surfaces on rolling bodies and running surfaces is crucial for a complete quality control. If measurement is impossible, it is recommended to disassemble and inspect a few samples per shipment/lot. It is important to scan the entire surface of the bearing parts. Even though most of the surface is nonmagnetic, small, highly magnetic spots may still remain and are only detected by a thorough search.
